The Re-Paint

Auto Masters

From the Desk of Jim Van Dorn

3/18/07

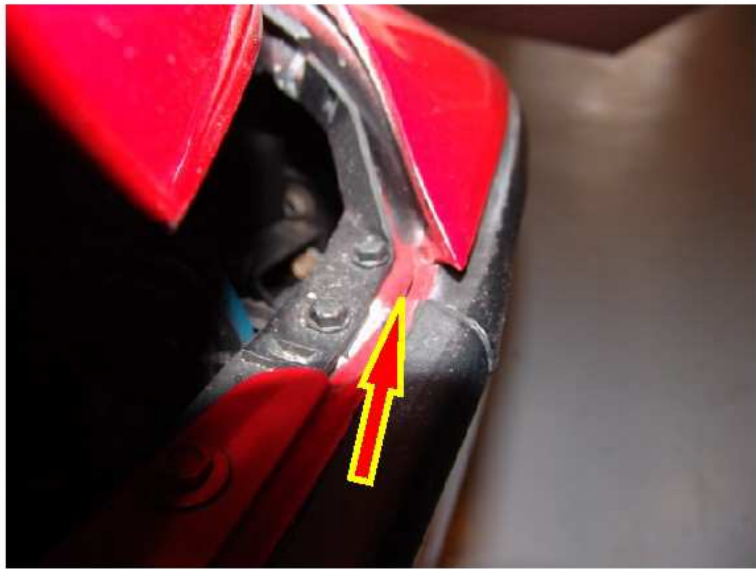
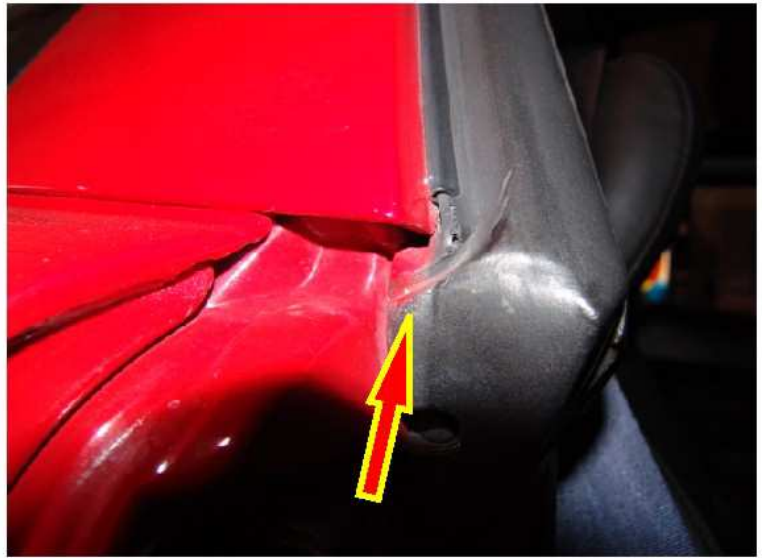
G20

This vehicle was advertised as a garaged kept, immaculate condition vehicle with only 9200 miles. There has been a very professional attempt to make this vehicle appear so. However, along with the many worn out items we discovered, along with a distant repaint, the evidence does not support that description.

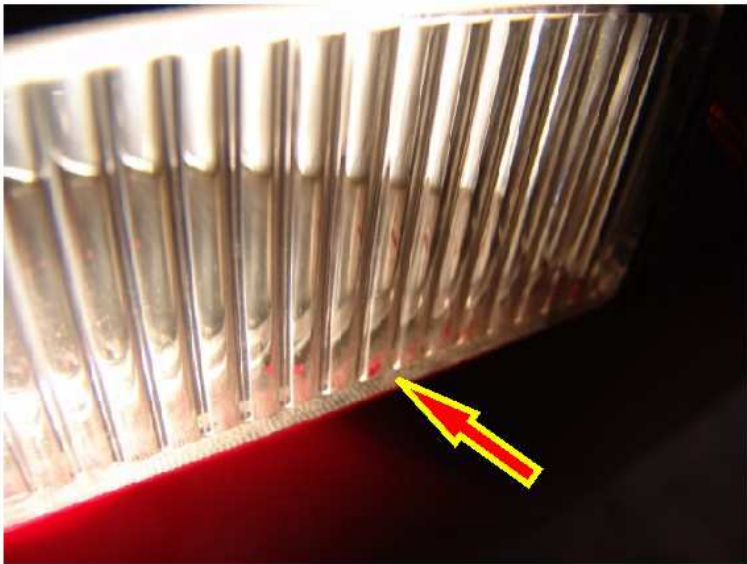
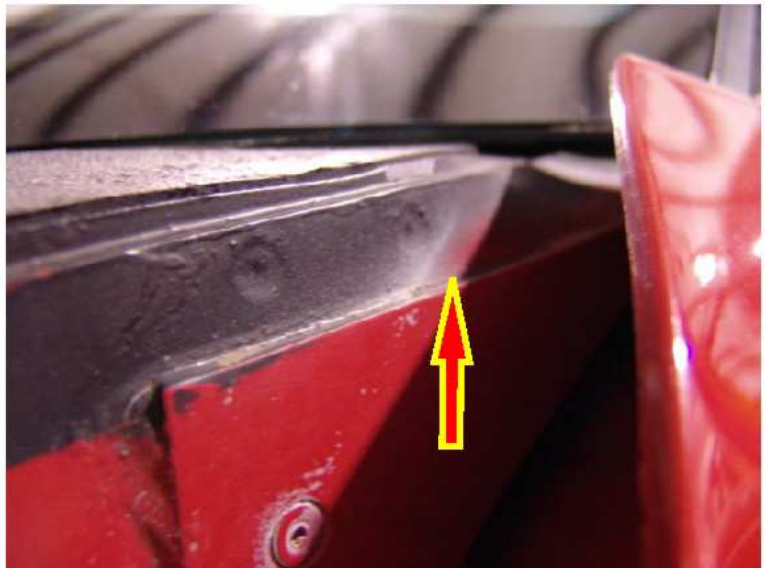
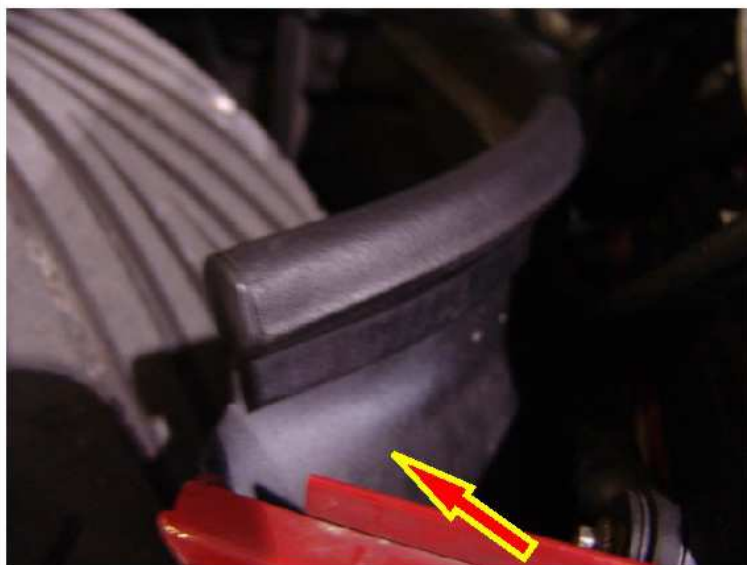
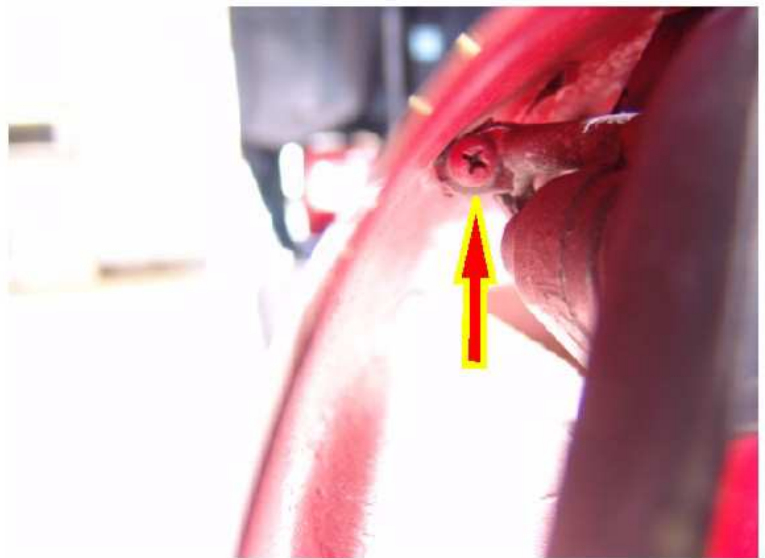
Top left: Overspray on front beltline molding. Car is originally painted with no molding attached.
Top Right: Weatherstripping overspray. Above left: Paint chips actually inside rear marker lens.
Above right and below left: Primer overspray. Below right: Inside mirror overspray (should be unpainted).

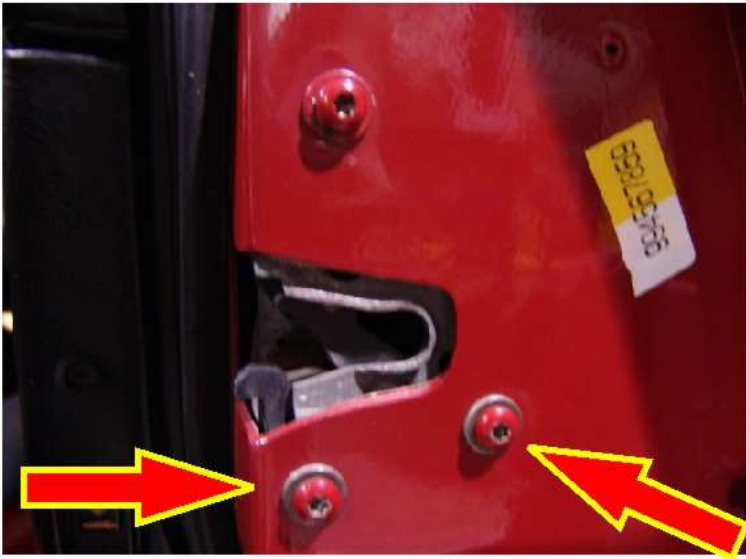
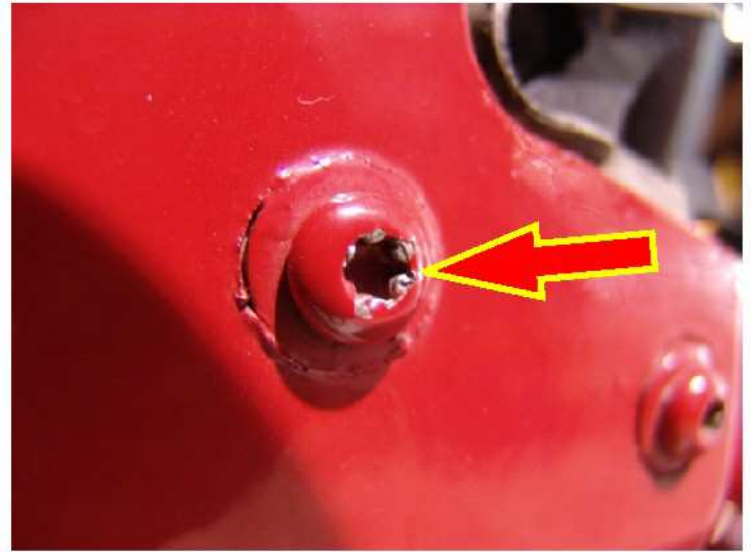
G21

Both doors have had the latch screws removed and have been repainted indicating the latches were removed prior to painting.

It is unknown what this label is affixed to the inside of the right door.

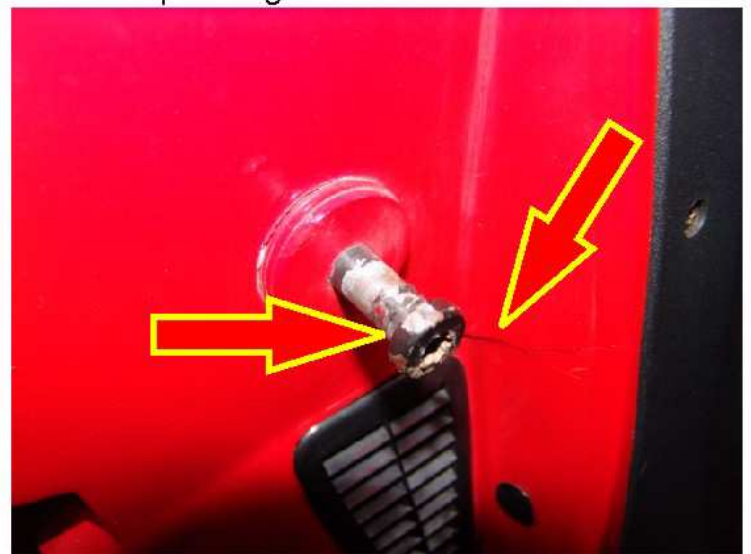
Below: The passenger door striker shows severe wear.

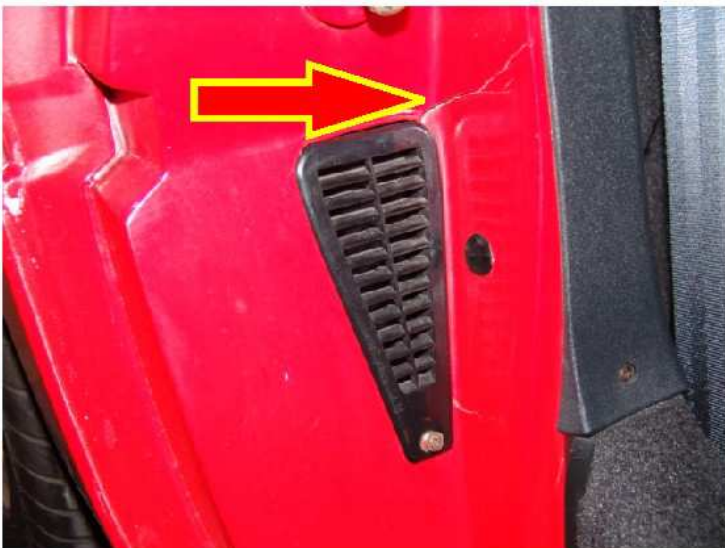
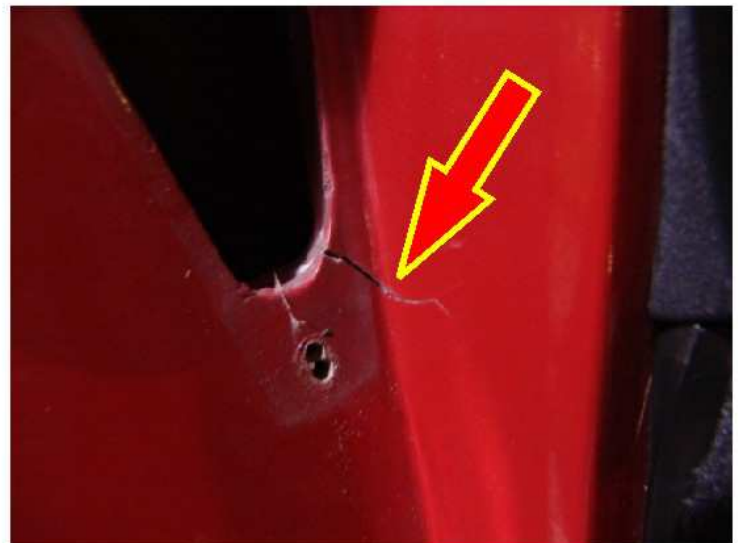
Below is the RH door vent. Closer inspection revealed massive cracking of the fiberglass in 2 areas.

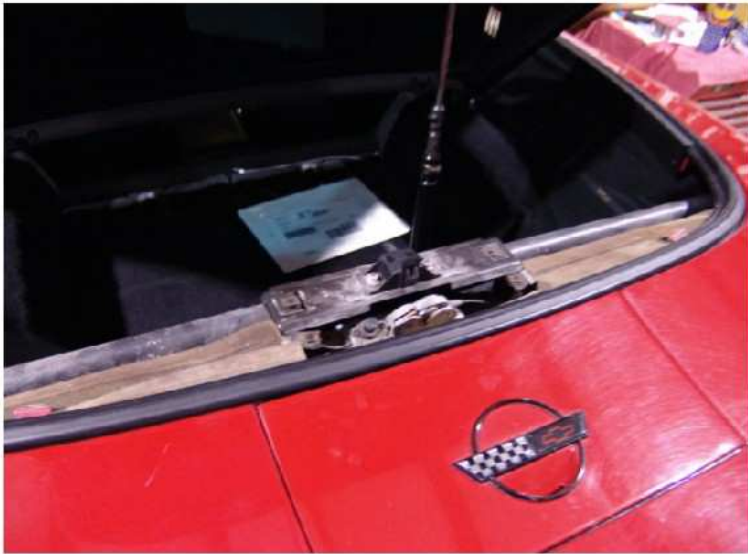
G22

The cargo area has been re-carpeted and the weatherstrip seal replaced. It appears new.

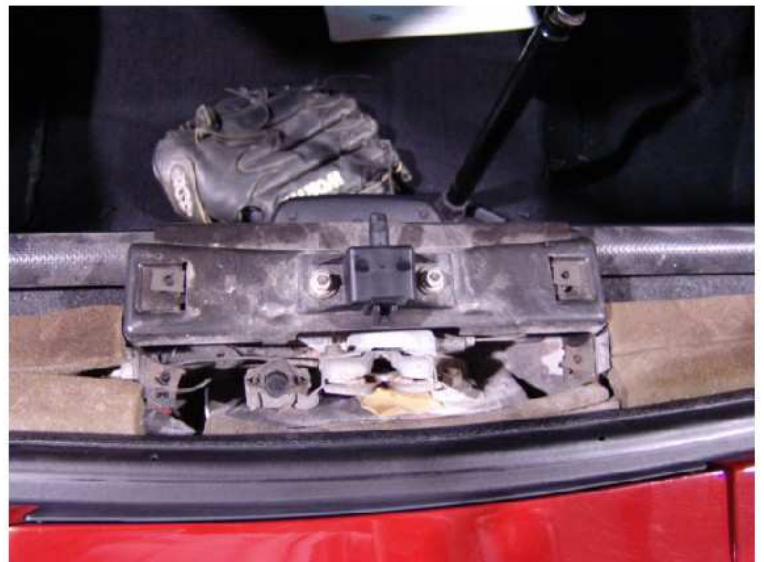
Under the rear trim molding the latch mechanism is rusted and corroded. Note the small piece of sandpaper found under the trim piece.

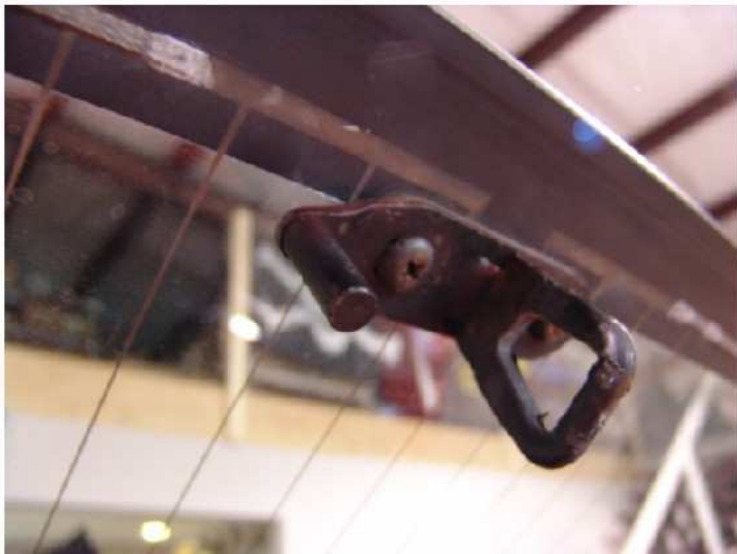
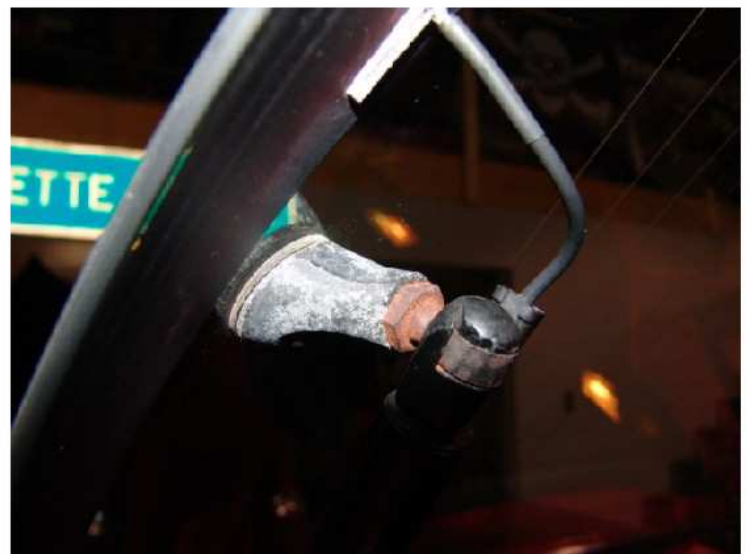
The hatch latch matches the extreme wear and corrosion found all over the vehicle. The prop rod anchors show more of the same. The rods themselves were painted over rust.

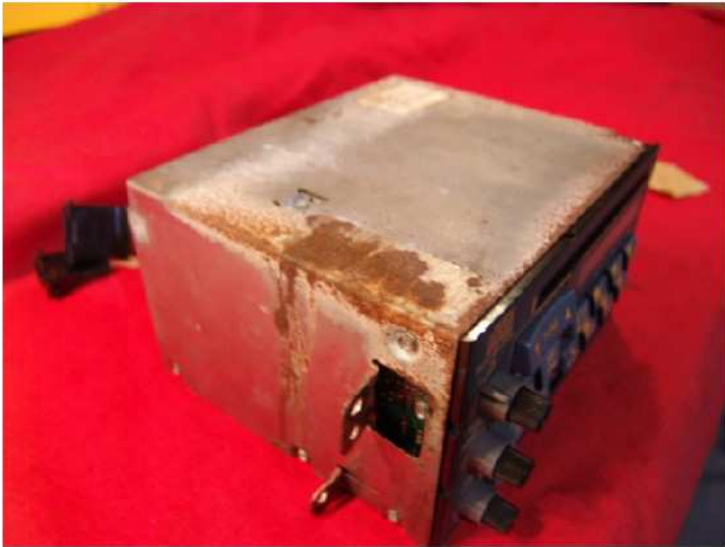
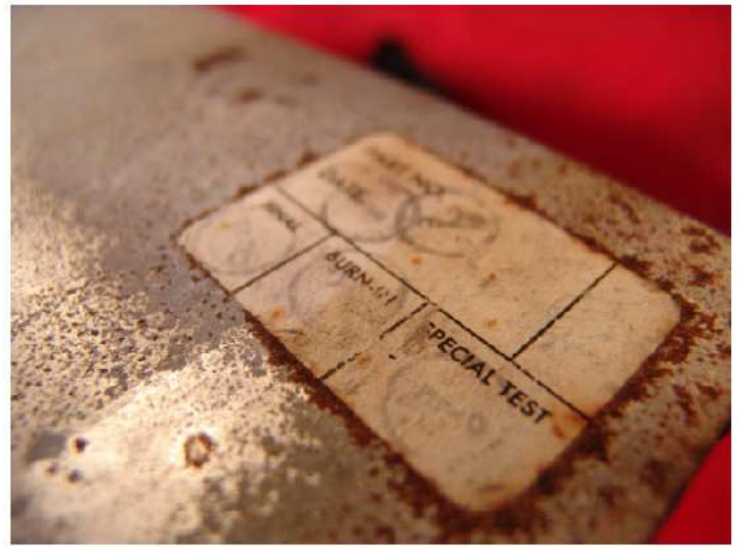
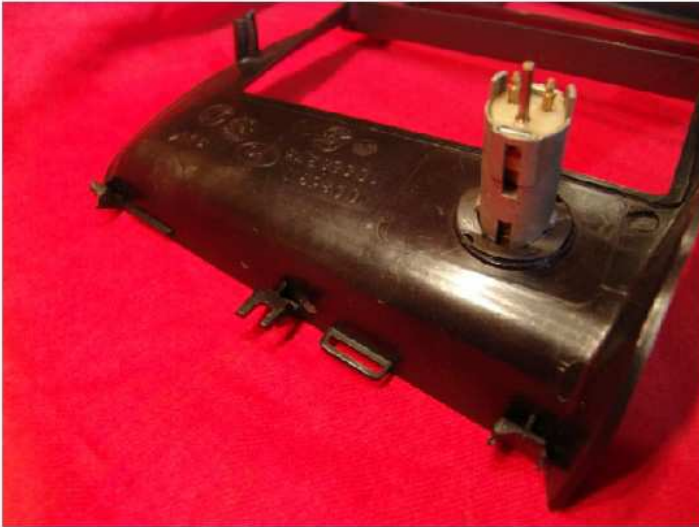
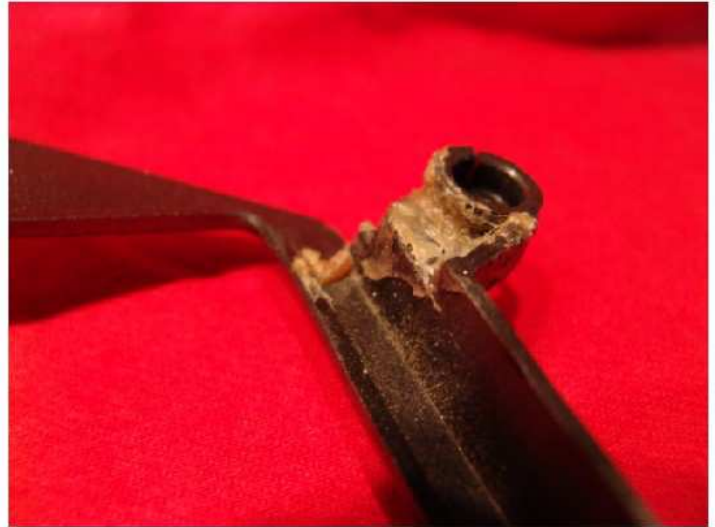
G23

The radio unit shows the same rusty, under-water type corrosion seen all over the vehicle. Below: The radio faceplate has several broken retaining clips. One is repaired with glue. The faceplate is also painted a metallic paint instead of the factory un-coated finish.

This vehicle is rusted or suffers from extreme corrosion throughout including most all steel fasteners under the dash, radio, seats, latches and mounting brackets. Several paper labels were examined and appear most likely to have been in contact with water at some point. Those labels were attached to the radio which was heavily rusted, and the CCM which is aluminum and oxidized by moisture. This vehicle was either under water, kept very close to a saltwater environment unprotected and uncovered, or both.

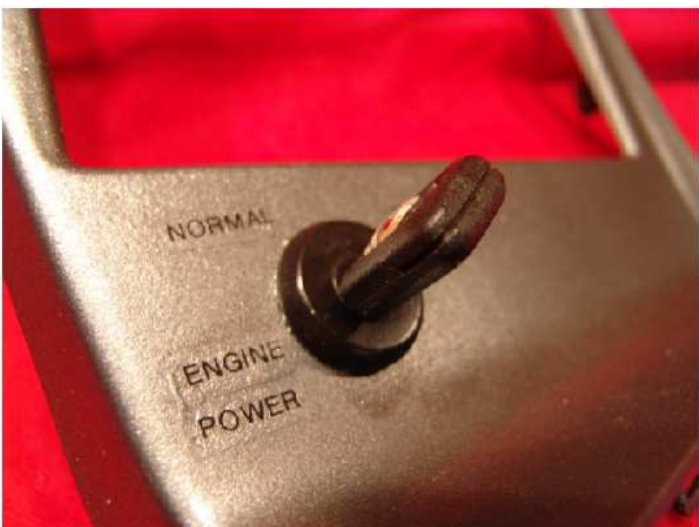
The Valet Key settings are labeled with clear tape labels rather than the orange paint lettering of the other interior indicators.

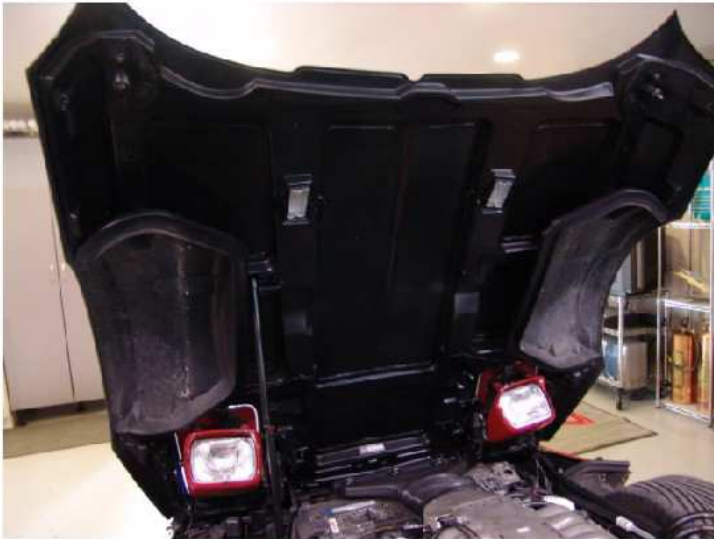
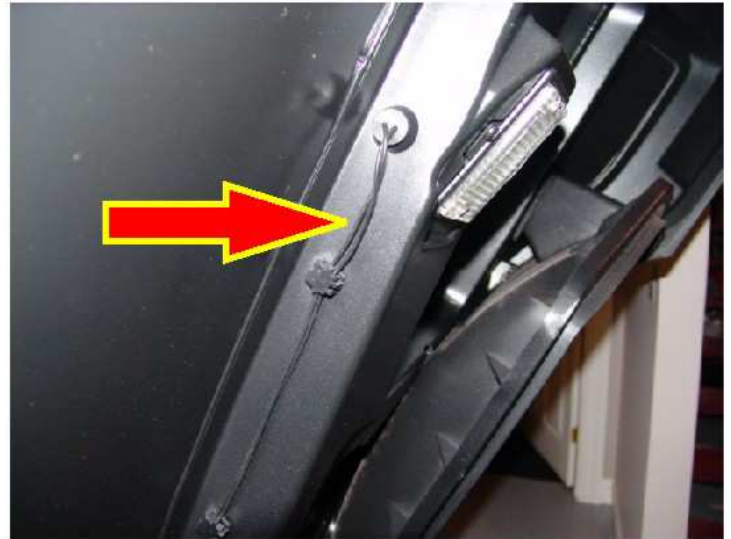
G24

At first glance the engine bay looks very presentable. Closure inspection shows the complete repaint of the underhood. Above right shows the lamp wiring painted black instead normal wire color (green).

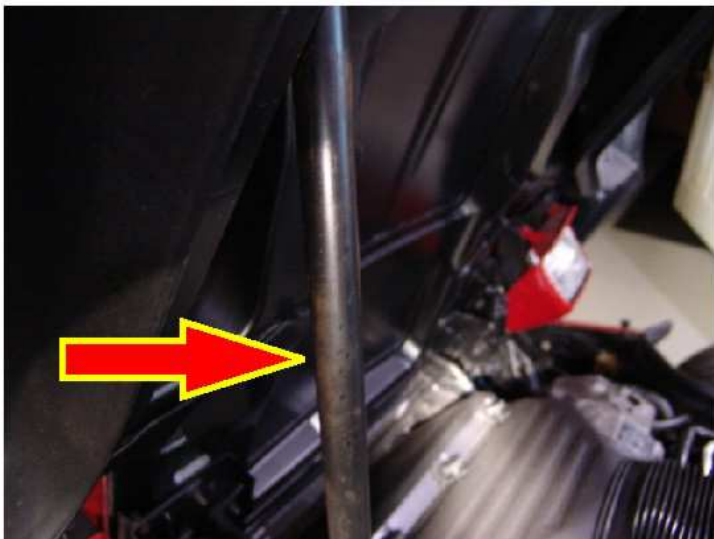
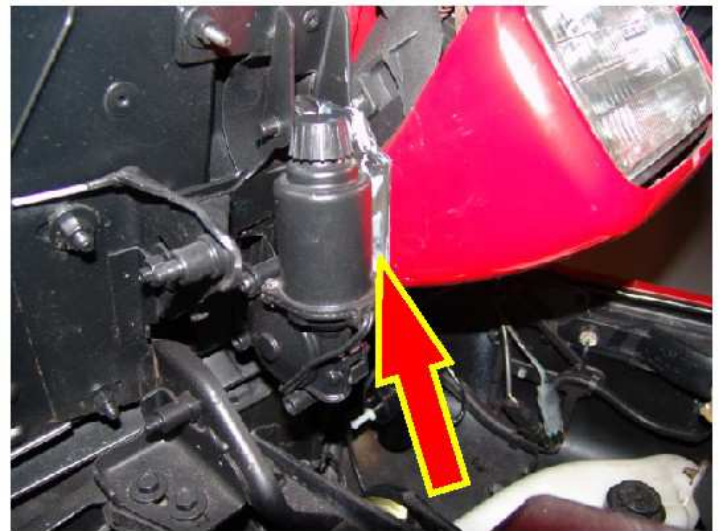
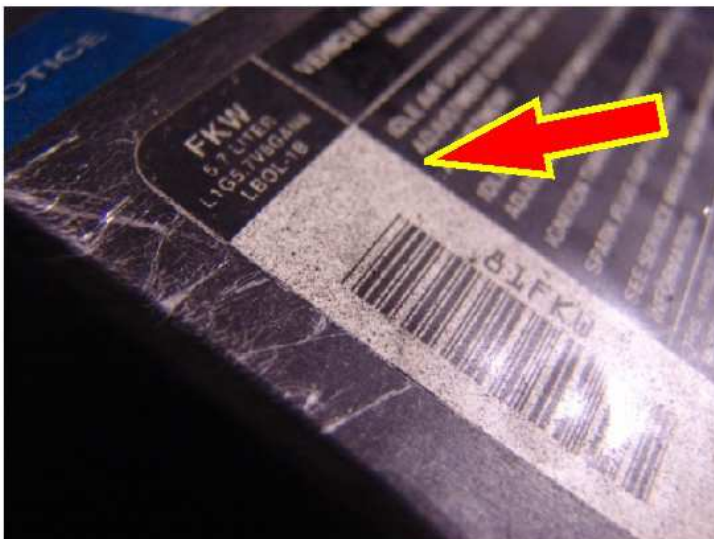
Below the hood support rod shows rust, wear and black overspray. The HL actuator below shows overspray.

The under hood emissions label shows black overspray.
